**THE EFFECTS OF ENVIRONMENT ON THE INTERLAMINAR SHEAR
PERFORMANCE OF AN OXIDE/OXIDE CERAMIC MATRIX COMPOSITE AT
ELEVATED TEMPERATURE**

THESIS

AFIT/GAE/ENY/07-J11

AIR FORCE INSTITUTE OF TECHNOLOGY

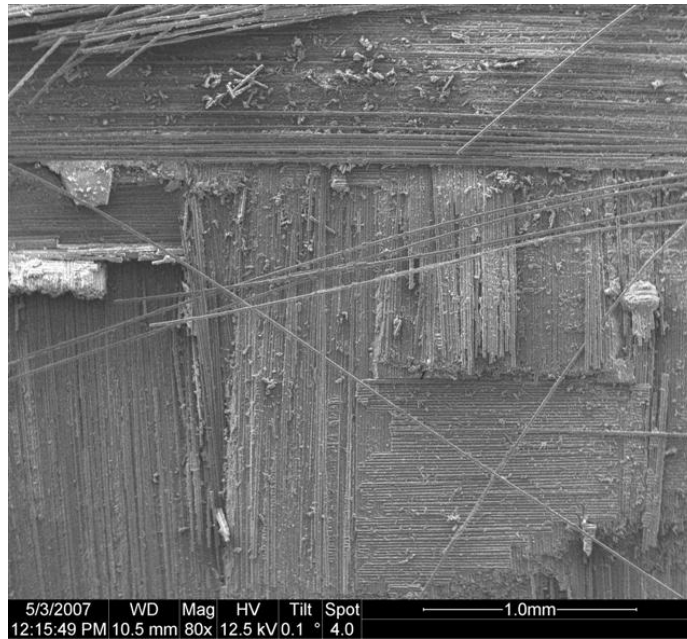
Figure 198: Fracture surface of the N720/A specimen aged in steam at 1200°C for 24 h prior to compression to failure.

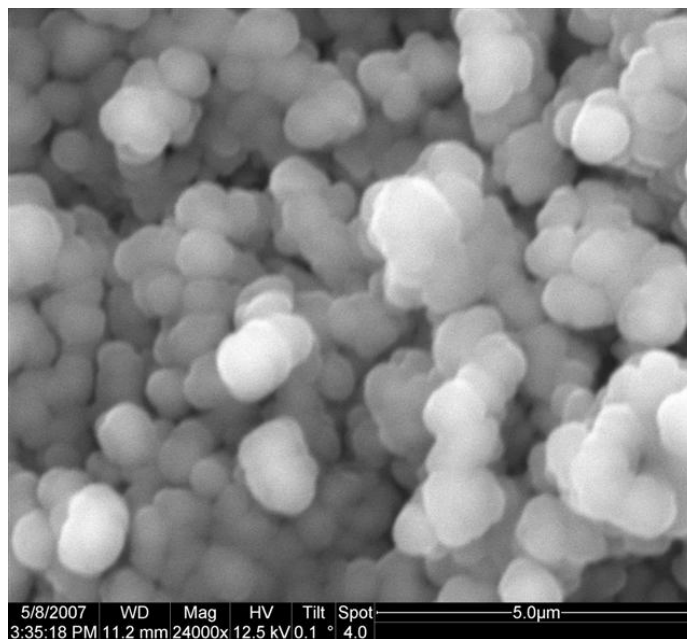
Figure 199: Fracture surface of the N720/A specimen aged in steam at 1200°C for 24 h prior to compression to failure.

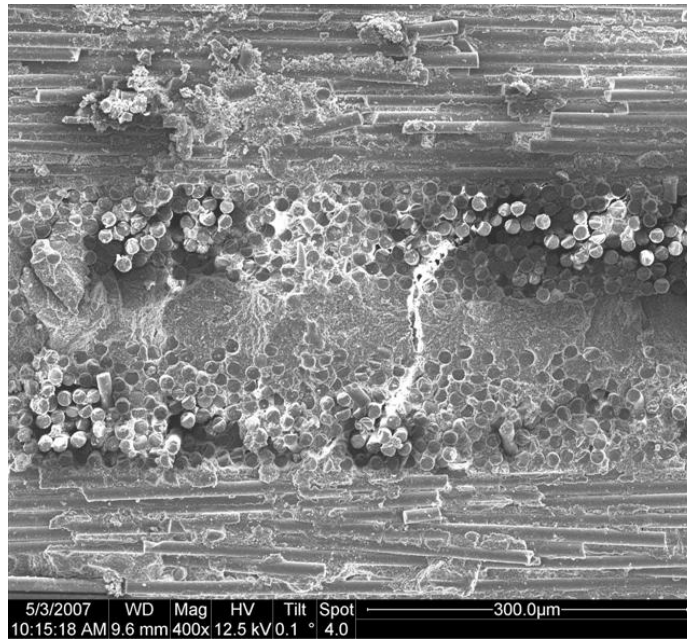
Figure 200: Side view of the fracture surface of the N720/A specimen tested in -4.0 MPa creep in steam at 1200°C .

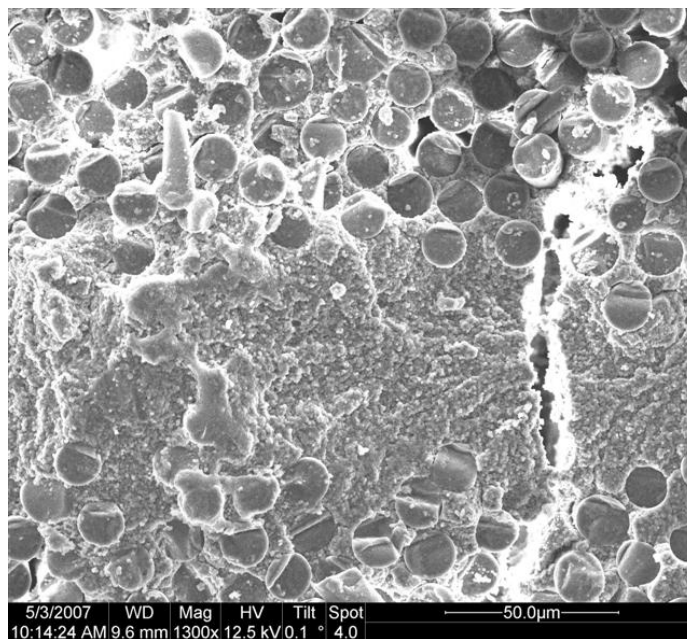
Figure 201: Close-up of Figure 200.

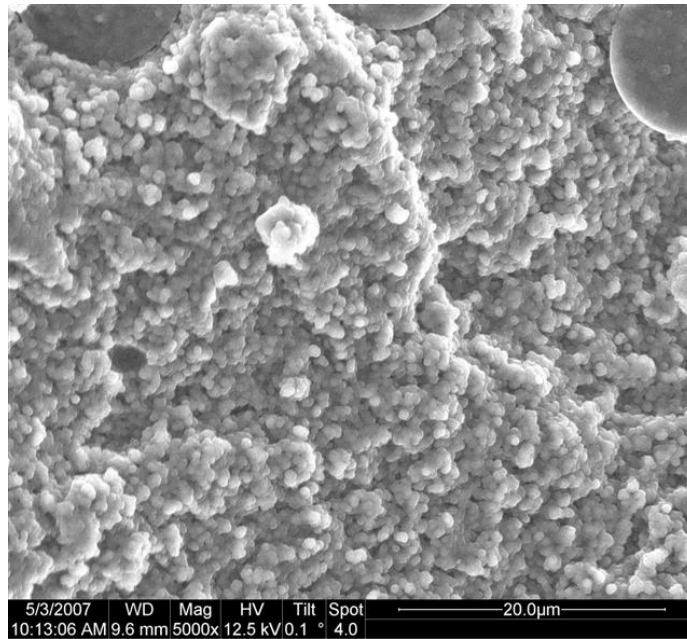
Figure 202: Close-up of Figure 201.

Page
Figure 200: Side view of the fracture surface of the N720/A specimen tested in –4.0 MPa creep in steam at 1200°C.	145
Figure 201: Close-up of Figure 200.....	145
Figure 202: Close-up of Figure 201.....	146
Figure 203: Side view of the fracture surface of the N720/A specimen tested in –4.0 MPa creep in steam at 1200°C.	146
Figure 204: Close-up of Figure 203.....	147
Figure 205: Close-up of Figure 204.....	147
Figure 206: Close-up of Figure 205.....	148
Figure 207: Close-up of Figure 206.....	148
Figure 208: Side view of the fracture surface of the N720/A specimen tested in –4.0 MPa creep in steam at 1200°C.	149
Figure 209: Side view of the fracture surface of the N720/A specimen tested in –4.0 MPa creep in steam at 1200°C.	149
Figure 210: Fracture surface of the N720/A specimen tested in –4.0 MPa creep in steam at 1200°C.	150
Figure 211: Close-up of Figure 210.....	150
Figure 212: Fracture surface of the N720/A specimen tested in –4.0 MPa creep in steam at 1200°C.	151

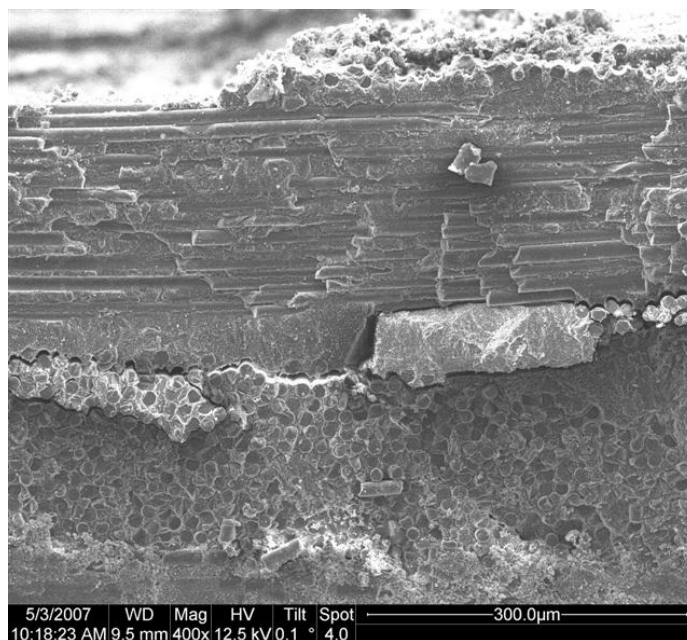
Figure 203: Side view of the fracture surface of the N720/A specimen tested in -4.0 MPa creep in steam at 1200°C .

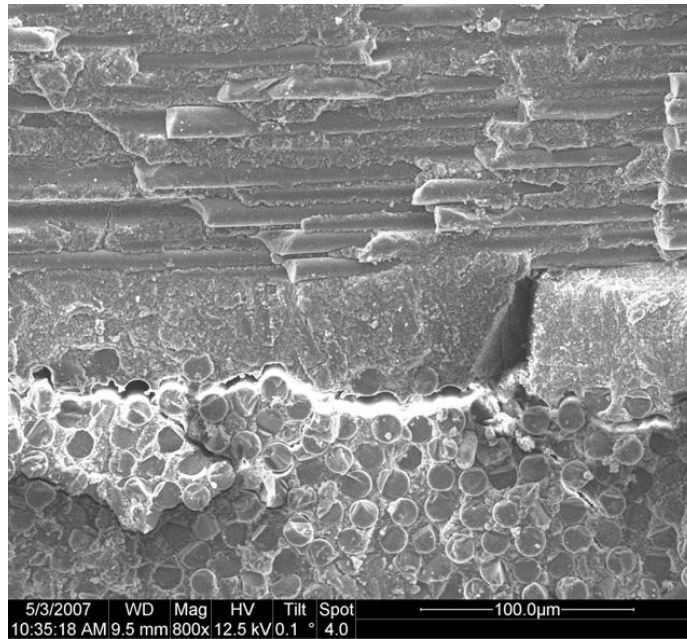
Figure 204: Close-up of Figure 203.

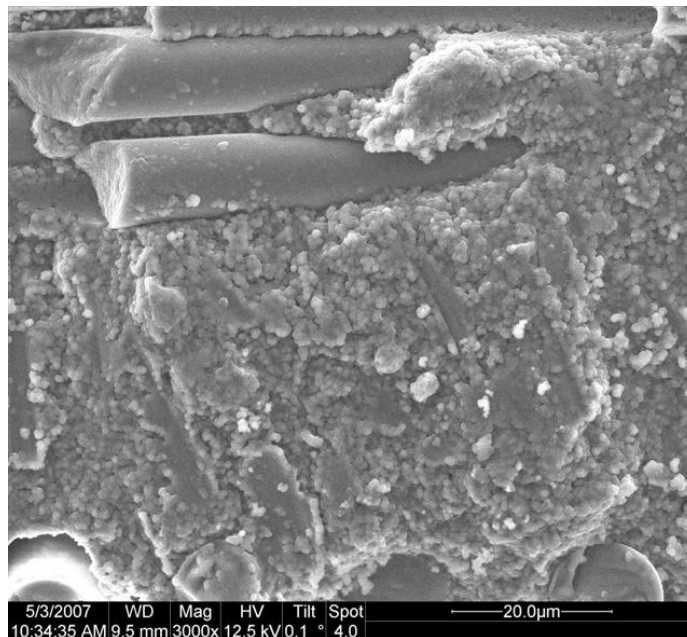
Figure 205: Close-up of Figure 204.

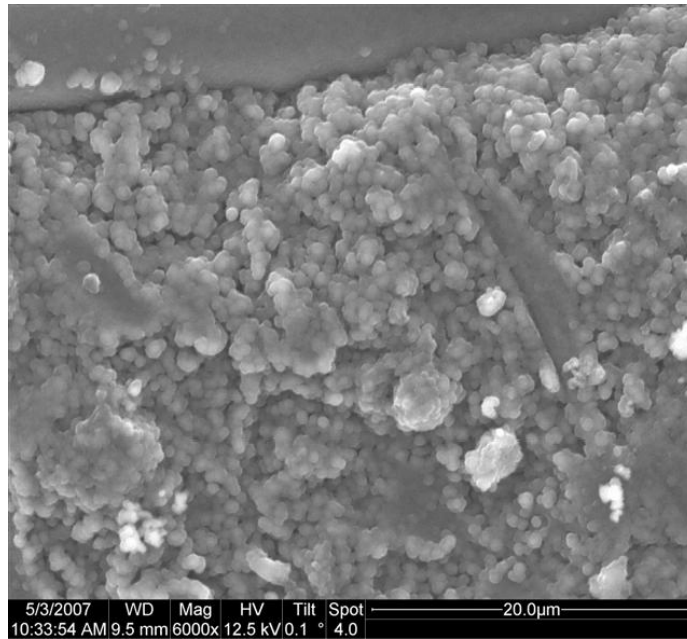
Figure 206: Close-up of Figure 205.

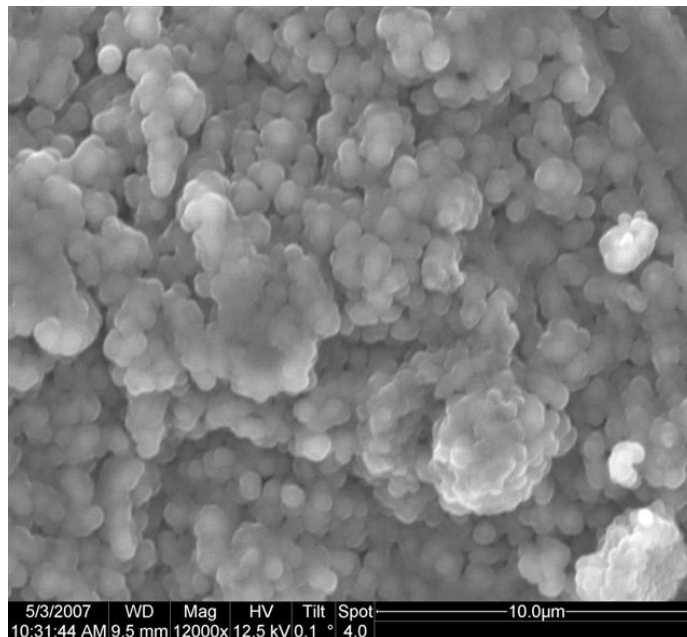
Figure 207: Close-up of Figure 206.

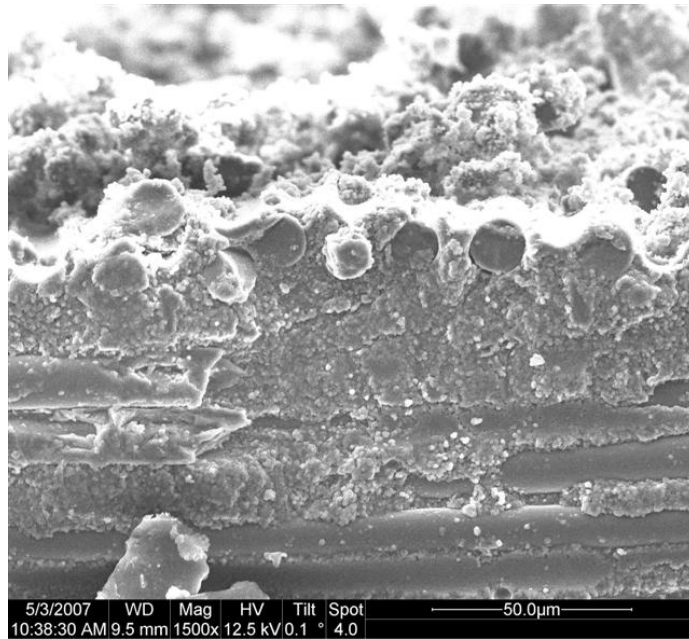
Figure 208: Side view of the fracture surface of the N720/A specimen tested in -4.0 MPa creep in steam at 1200°C .

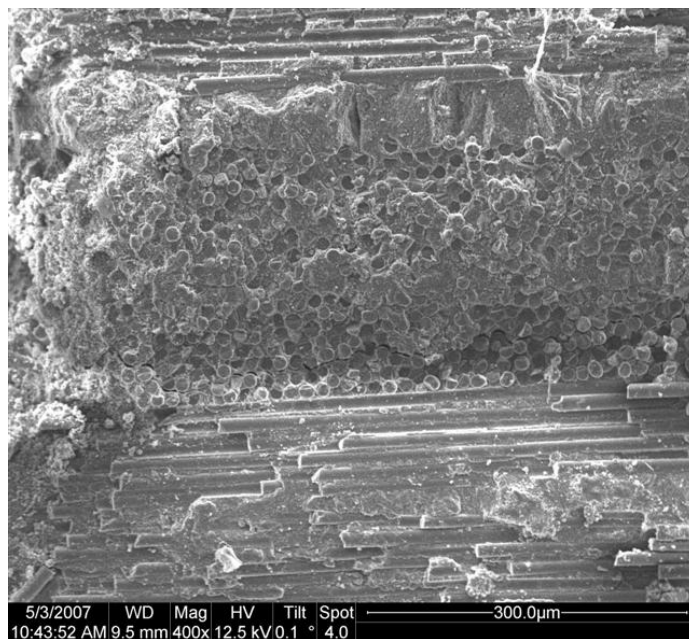
Figure 209: Side view of the fracture surface of the N720/A specimen tested in -4.0 MPa creep in steam at 1200°C .

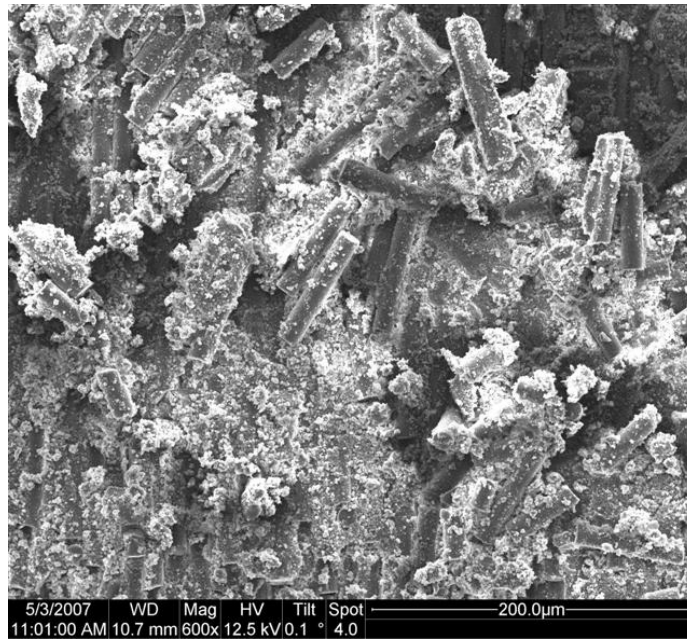
Figure 210: Fracture surface of the N720/A specimen tested in -4.0 MPa creep in steam at 1200°C .

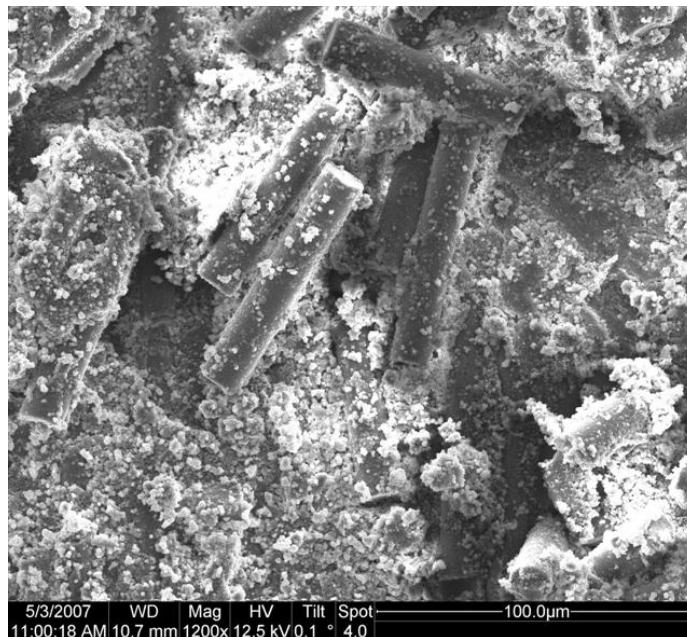
Figure 211: Close-up of Figure 210.

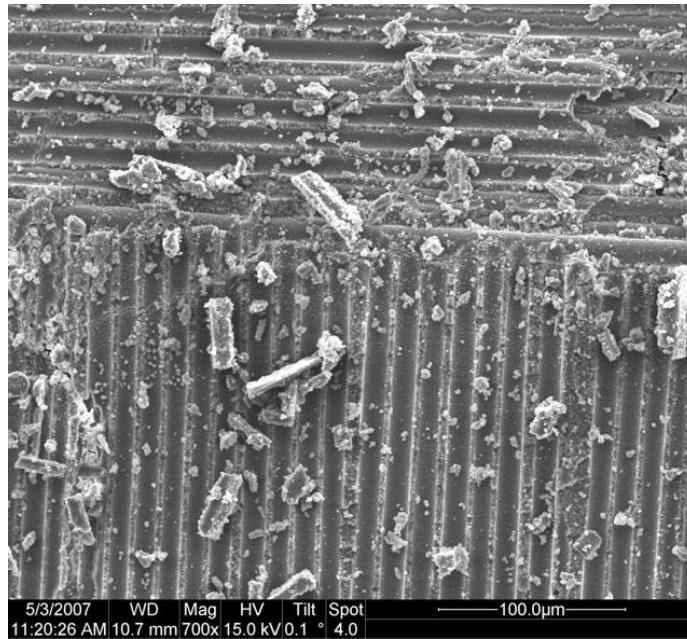
Figure 212: Fracture surface of the N720/A specimen tested in -4.0 MPa creep in steam at 1200°C .

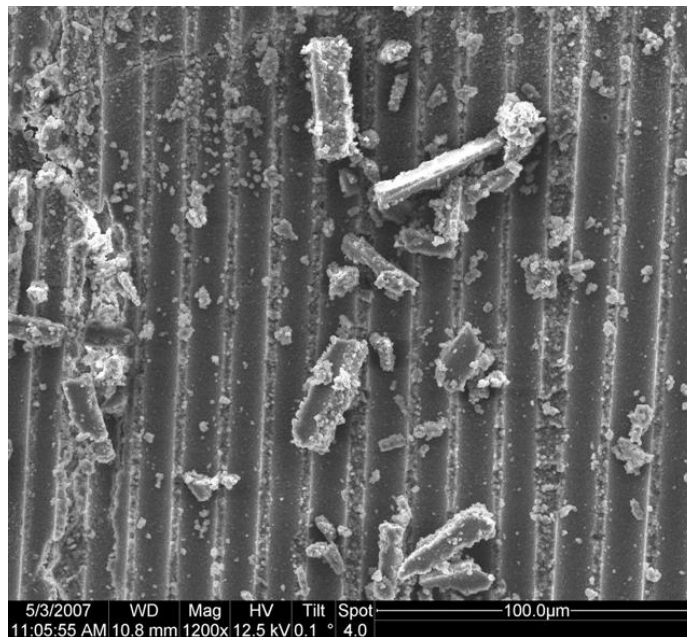
Figure 213: Close-up of Figure 212.

Figure 213: Close-up of Figure 212.....	151
Figure 214: Close-up of Figure 212.....	152
Figure 215: Close-up of Figure 214.....	152
Figure 216: Fracture surface of the N720/A specimen tested in –4.0 MPa creep in steam at 1200°C.	153

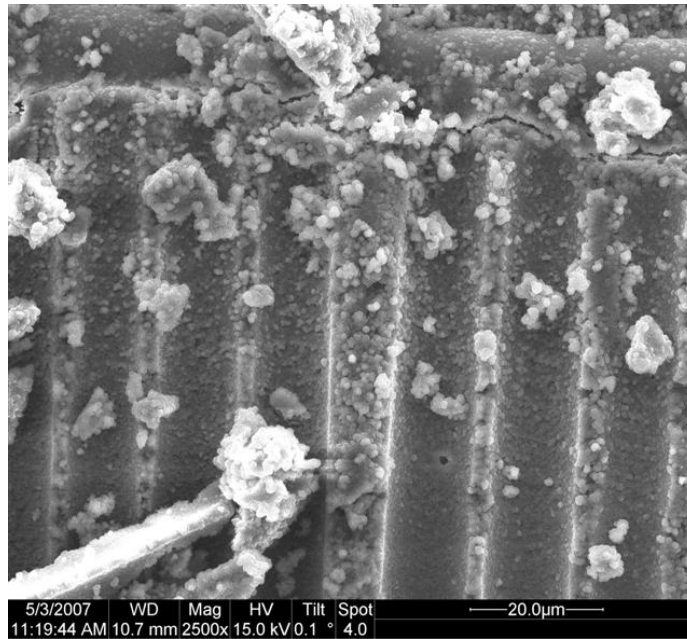
Figure 214: Close-up of Figure 212.

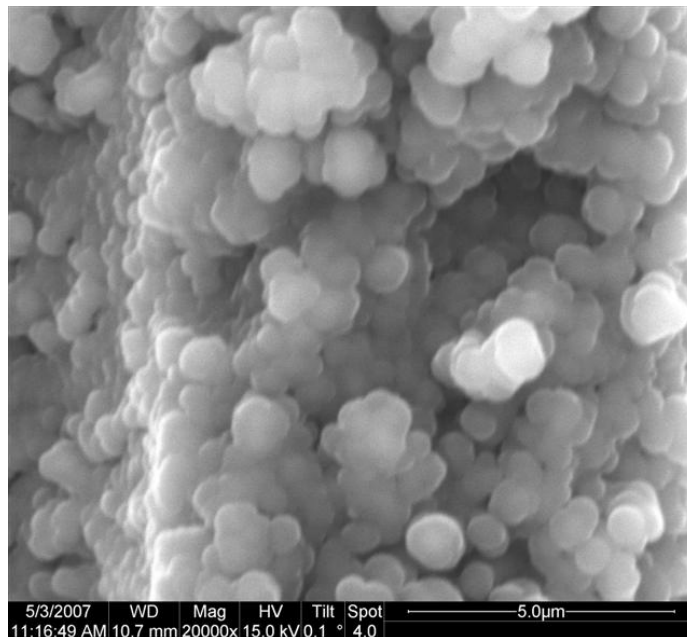
Figure 215: Close-up of Figure 214.

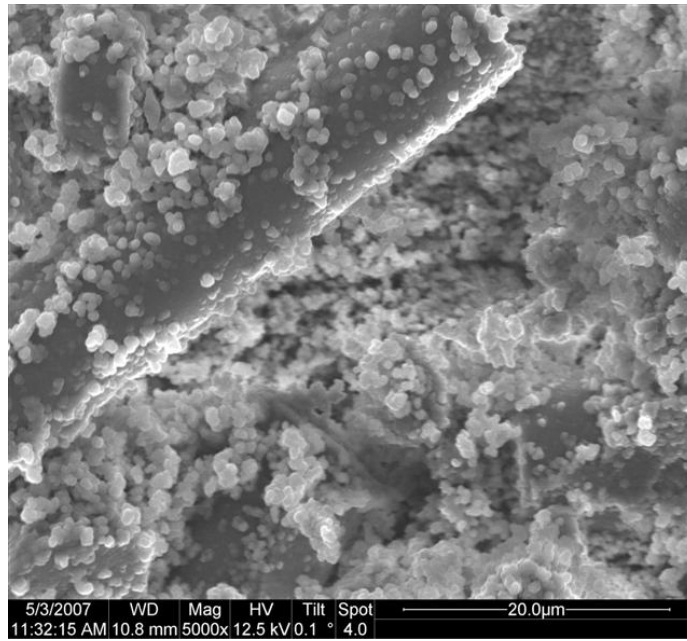
Figure 216: Fracture surface of the N720/A specimen tested in –4.0 MPa creep in steam at 1200°C.
